Final GMP inspection report

ZHEJIANG HUAHAI PHARMACEUTICAL CO., LTD.**Chuannan, Duqiao, Linhai****Zhejiang 317016, China**From now onwards referred to as: **ZHP Chuannan**

EDQM: INSP 2018-039-P01

Inspection date: 10 – 13 September 2018**Inspectors:**

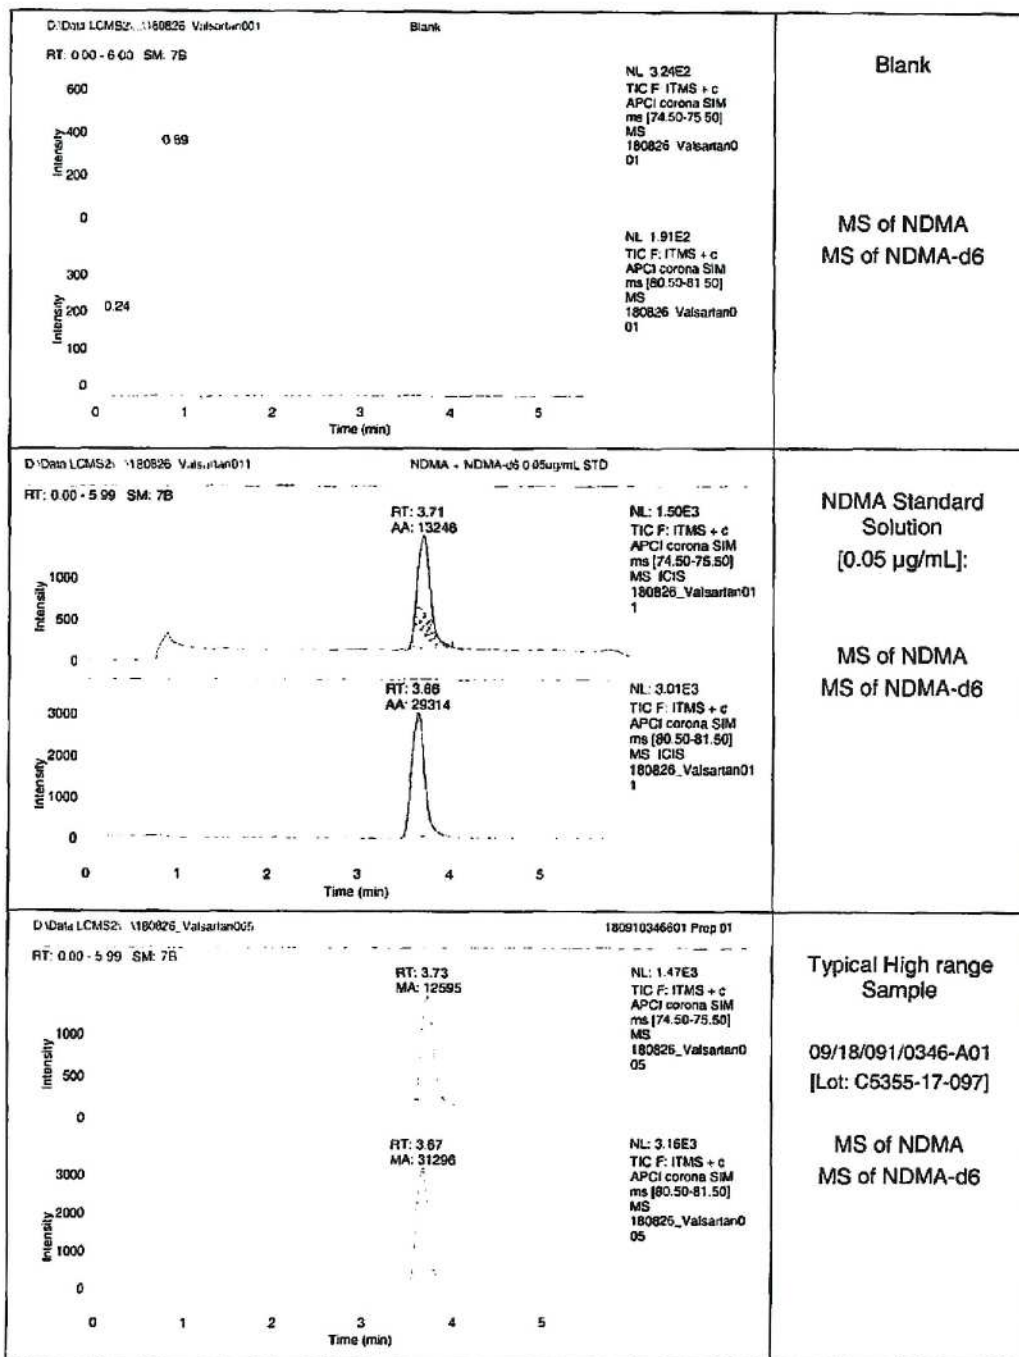
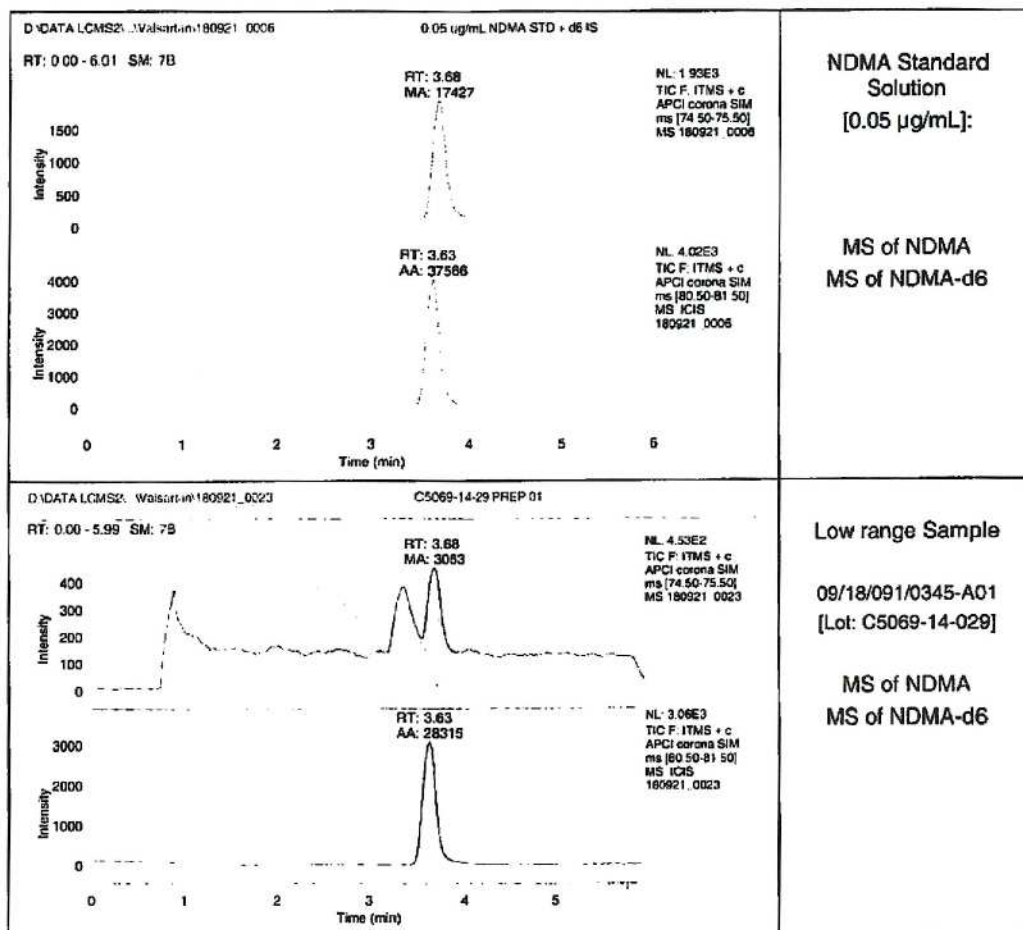
5. Chromatograms

The NDMA results for the API samples were similar to those provided by the manufacturer, with the exception of 09/18/091/0344-A01 (lot: C5271-17-288). The result supplied with this sample was declared as 'Not Detected', but it was noted that this result was 'out-of-trend' with comparable batches. Our results showed that this sample contained NDMA at an average level of 96.6 ppm.
